Safety & health lessons learnt

Formwork Incident

This report has been prepared to share the lessons learnt from a formwork failure incident.

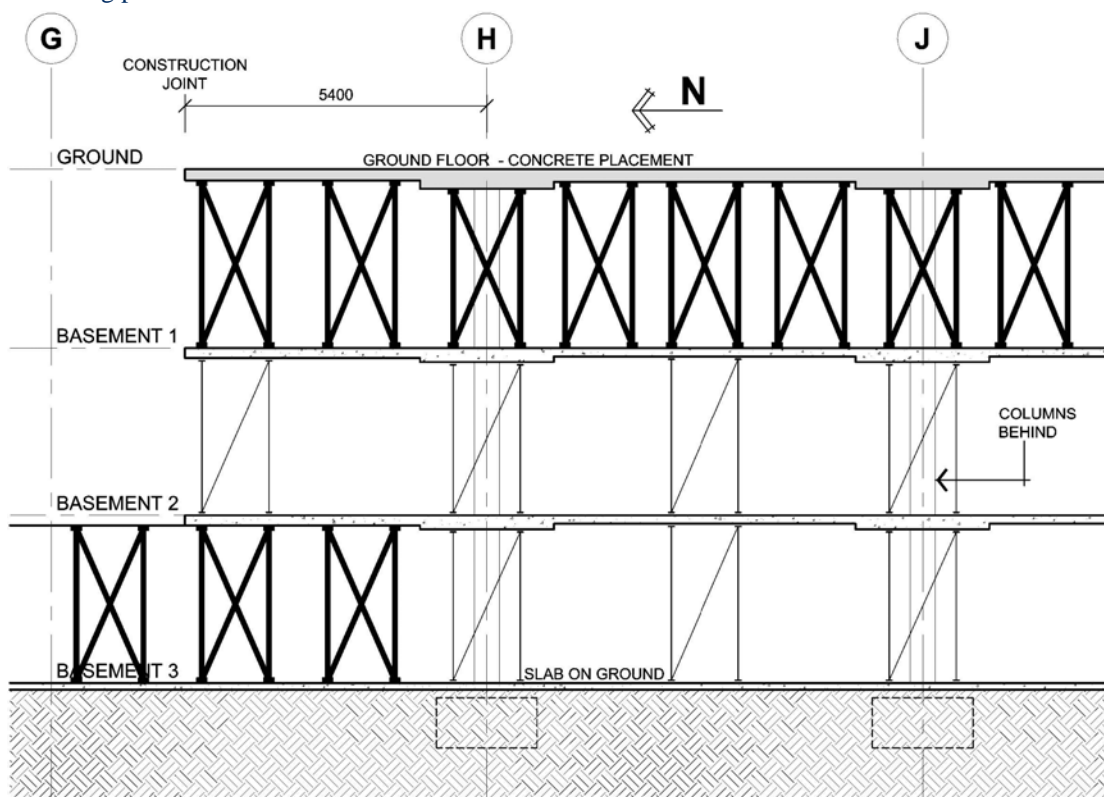
Figure 1 below is a typical section showing the status of construction at the time of the incident when concrete was being placed to the Ground Floor slab.

The suspended Basement 1 and Basement 2 floor slabs are designed as post tensioned banded slabs and both suspended slabs had been fully stressed and grouted.

The sections of Basement 1 and Basement 2 slabs north of Grid H were detailed with a construction joint at approximately 2/3 span towards Grid G. The sections of slab between Grid G and Grid H were completed up to the construction joint only. They would remain in this condition until adjacent slabs, north of the construction joint were formed and cast. With limited capacity to act as a cantilever, these slab sections relied on formwork and backpropping for support.

Figure 1 shows areas that were fully formed and propped and those which had been stripped and backpropped. In summary the installations were as follows:

- 📄 Between Basement 1 and Ground Floor the full formwork system was in place to support the wet concrete placement to the Ground Floor.
- 📄 Between Basement 2 and Basement 1 the formwork had been stripped and replaced with a system of backprops.
- 📄 Between Basement 3 and Basement 2, south of Grid H, the formwork had been stripped and replaced with the system of backprops.
- 📄 Between Basement 3 and Basement 2, north of Grid H, the formwork remained in preparation for casting Basement 2 north of the construction joint.

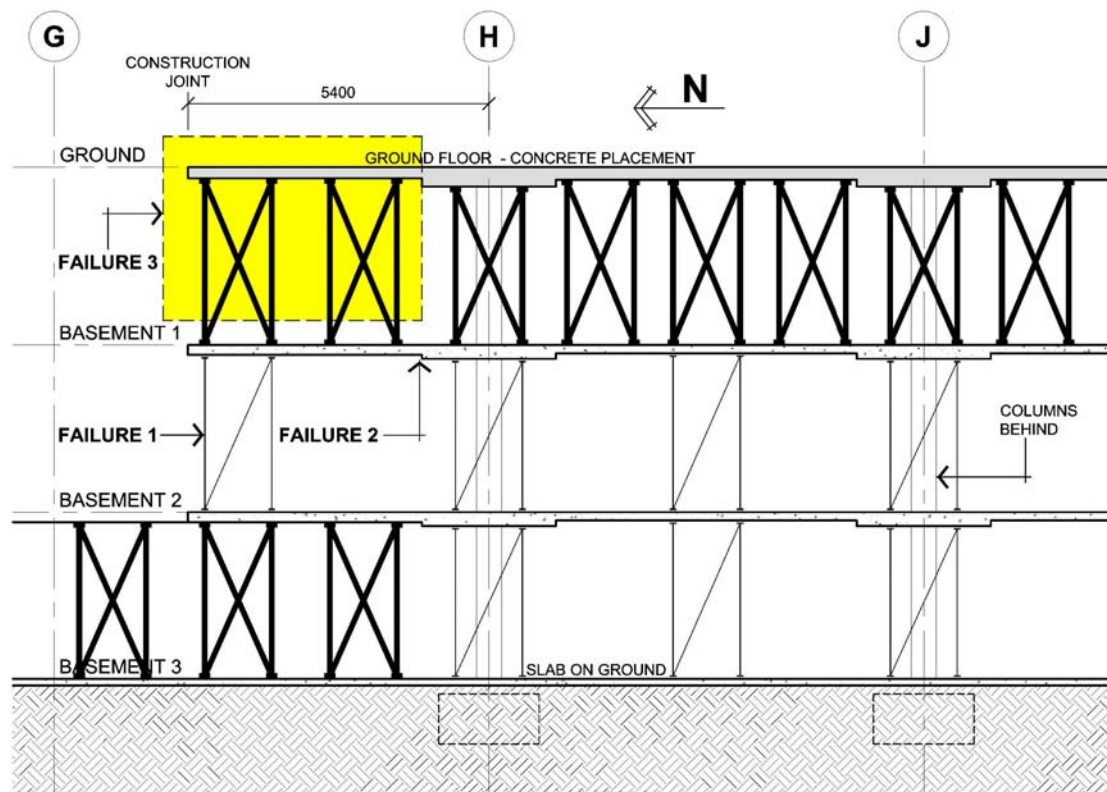
Figure 2 below highlights the sequence of the three failures that occurred, leading to the collapse of the formwork and wet concrete to the Ground Floor.

As the concrete was being placed to the Ground Floor, north of Grid H, the Basement 2 to Basement 1 backprops became overloaded and began to progressively fail across the entire width (east to west) of the Basement 1 slab, a distance of some 32 metres. The progressive failure of the backprops produced visible deflections in the Basement 1 slab, north of Grid H, alerting site staff and leading to the safe evacuation of all site personnel.

Failure 1 resulted in the full load of the Ground Floor wet concrete being carried by the now unsupported Basement 1 slab which in its temporary state, was now required to act as a cantilever. This load was in excess of the slabs structural capacity resulting in a progressive failure of the Basement 1 slab along the entire edge of the band beam (east to west) adjacent to Grid H.

At Failure Point 2 a “hinge” was created at the band beam / slab junction at Grid H. As a result the northern most edge of the Basement 1 slab rotated downwards, coming to rest on the Basement 2 slab below.

Without any support from the Basement 1 slab the formwork supporting the wet concrete to the Ground Floor (highlighted yellow in Figure 2) slid down the inclined surface of the collapsed section of Basement 1 slab and came to rest on the Basement 2 slab and formwork.

The Basement 2 slab, north of Grid H, remained intact throughout the incident.

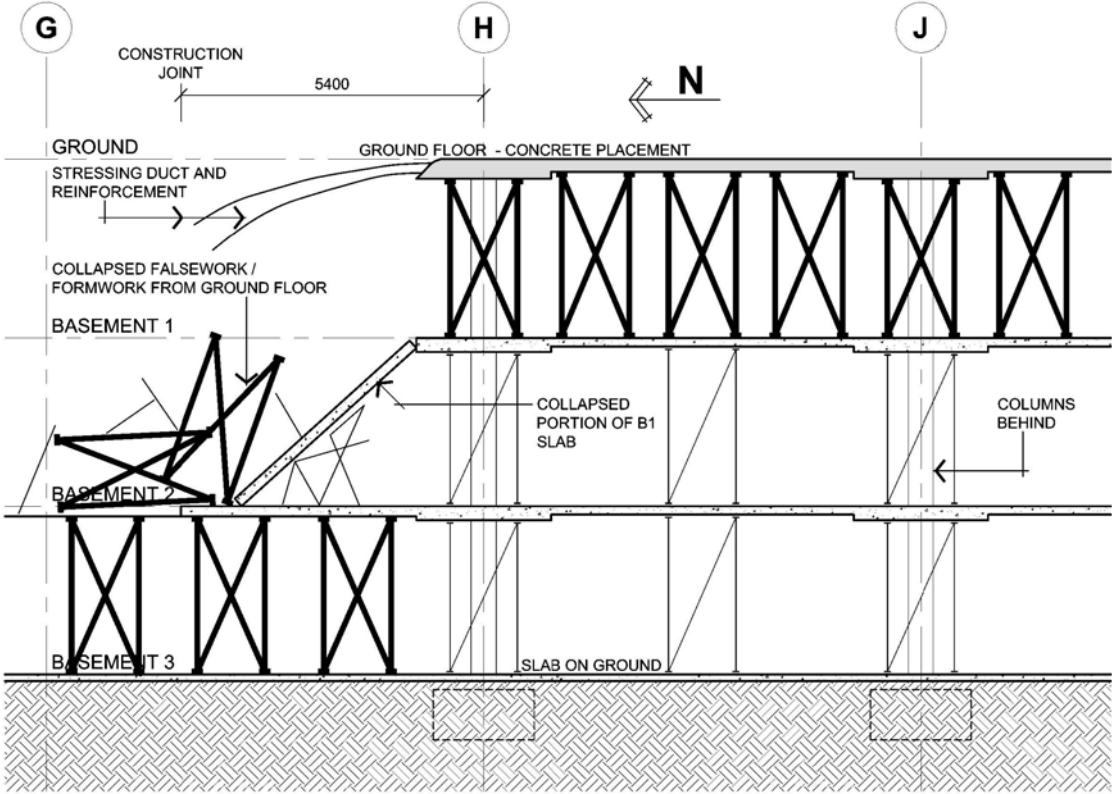
The result of the three failure mechanisms outlined above is demonstrated in Figure 3 below.

FIGURE 3 **POST COLLAPSE**
