Safety and Health lessons learnt: Formwork Incident

Introduction

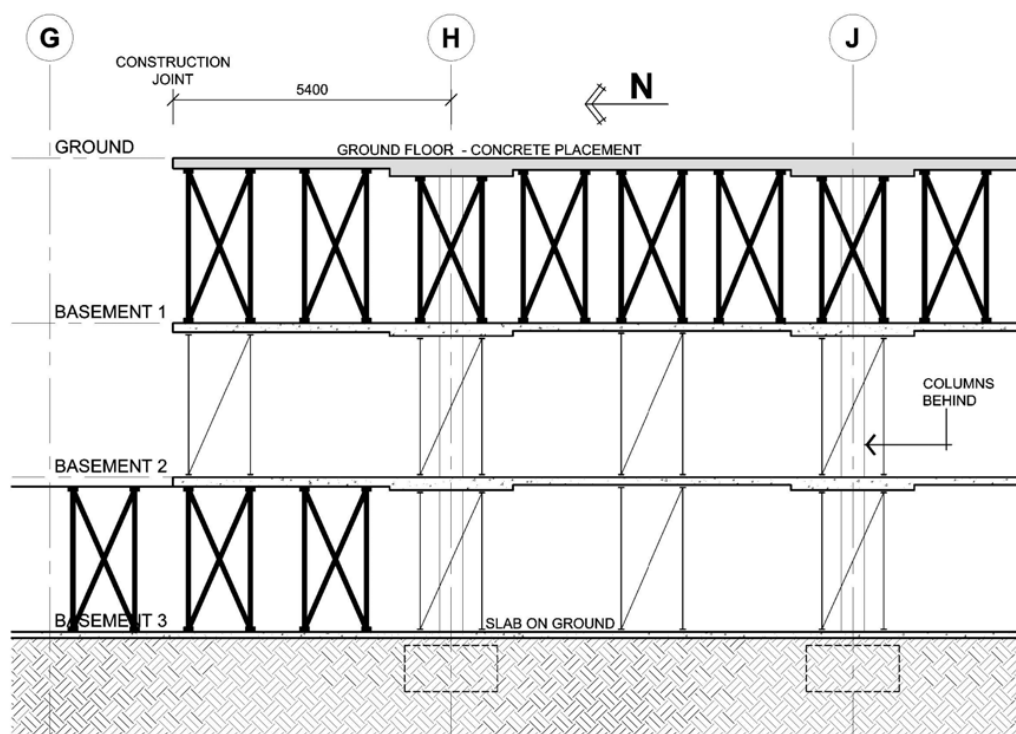
FIGURE 1

Figure 1 (below) shows a typical section showing the status of construction at the time of the incident when concrete was being placed to the Ground Floor slab.

Figure 1 shows areas that were fully formed and propped and those which had been stripped and backpropped. In summary the installations were as follows:

- Between Basement 1 and Ground Floor the full formwork system was in place to support the wet concrete placement to the Ground Floor.
- Between Basement 2 and Basement 1 the formwork had been stripped and replaced with a system of backprops.
- Between Basement 3 and Basement 2, south of Grid H, the formwork had been stripped and replaced with the system of backprops.

Between Basement 3 and Basement 2, north of Grid H, the formwork remained in preparation for casting Basement 2 north of the construction joint.

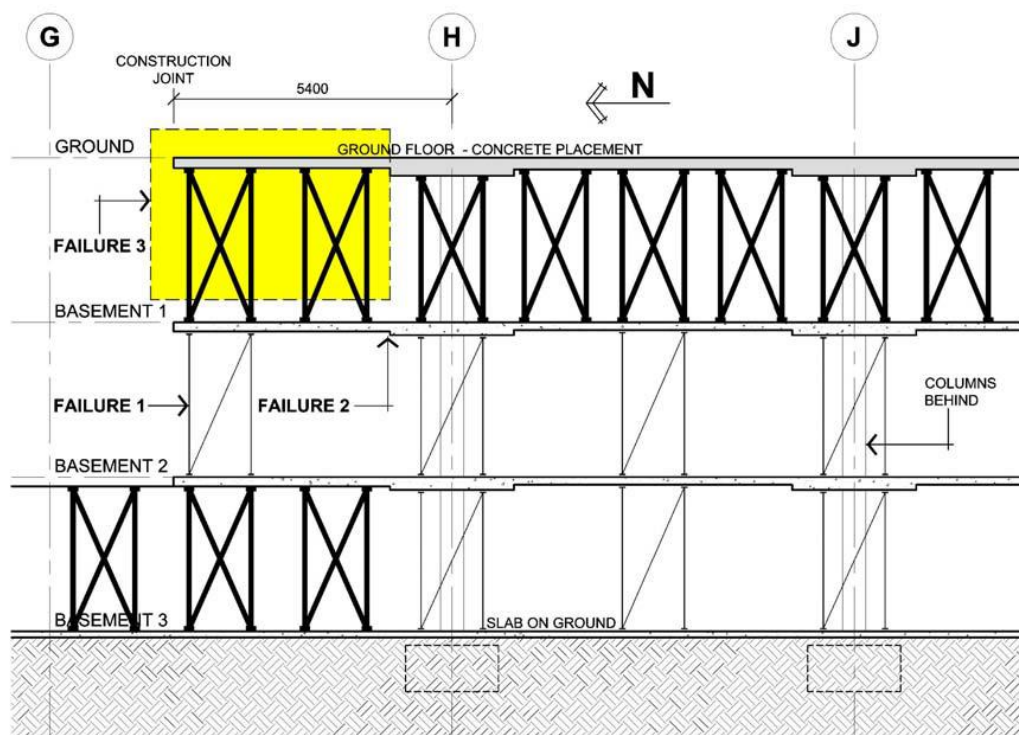
Figure 2 (below) highlights the sequence of the three failures that occurred, leading to the collapse of the formwork and wet concrete to the Ground Floor.

Failure 1 – Backpropping between Basement 2 and Basement 1

As the concrete was being placed to the Ground Floor, north of Grid H, the Basement 2 to Basement 1 backprops became overloaded and began to progressively fail across the entire width (east to west) of the Basement 1 slab, a distance of some 32 metres. The progressive failure of the backprops produced visible deflections in the Basement 1 slab, north of Grid H, alerting site staff and leading to the safe evacuation of all site personnel.

Failure 2 – Overloading of Basement 1 Slab, North of Grid H

Failure 1 resulted in the full load of the Ground Floor wet concrete being carried by the now unsupported Basement 1 slab which in its temporary state, was now required to act as a cantilever. This load was in excess

of the slabs structural capacity resulting in a progressive failure of the Basement 1 slab along the entire edge of the band beam (east to west) adjacent to Grid H. At Failure Point 2 a “hinge” was created at the band beam / slab junction at Grid H. As a result the northern most edge of the Basement 1 slab rotated downwards, coming to rest on the Basement 2 slab below.

Failure 3 – Collapse of Ground Floor Formwork

Without any support from the Basement 1 slab the formwork supporting the wet concrete to the Ground Floor (highlighted yellow in Figure 2) slid down the inclined surface of the collapsed section of Basement 1 slab and came to rest on the Basement 2 slab and formwork. The Basement 2 slab, north of Grid H, remained intact throughout the incident.

Principal Contractors must ensure that formwork and backpropping design drawings are produced that are project and area specific. This is because design loadings for the permanent structure vary from floor to floor, particularly as the project progresses from basement levels, through the Ground Floor and into typical tower floors.

- Principal Contractors must ensure that a review of the formwork and backpropping design is carried out by the Project Structural Engineer to verify that temporary imposed loads will not adversely affect the permanent structure.

- The Principal Contractor should provide marked-up drawings to the formworker which identify the areas that can be stripped and backpropped prior to the formworker commencing those activities.

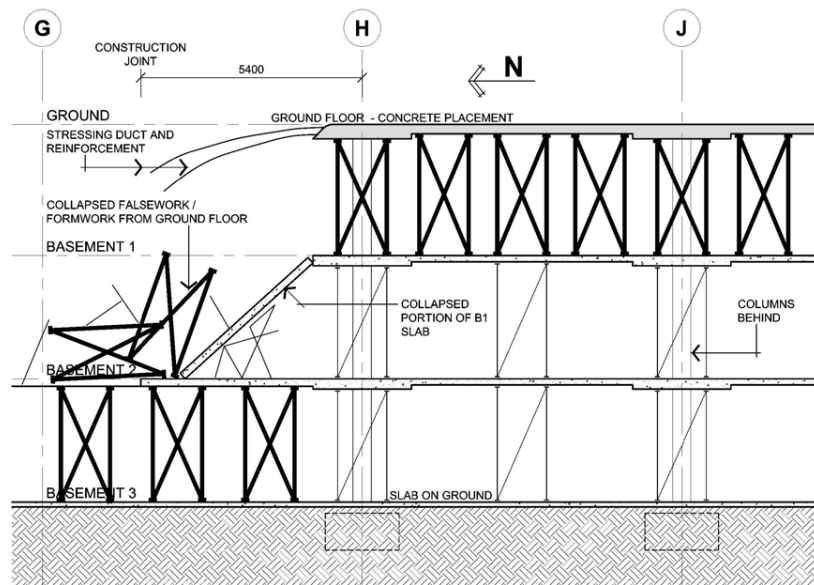
FIGURE 3

The result of the three failure mechanisms outlined above is demonstrated in figure 3 (below).

POST COLLAPSE
