Safety and Health lessons learnt: Formwork Incident

Introduction

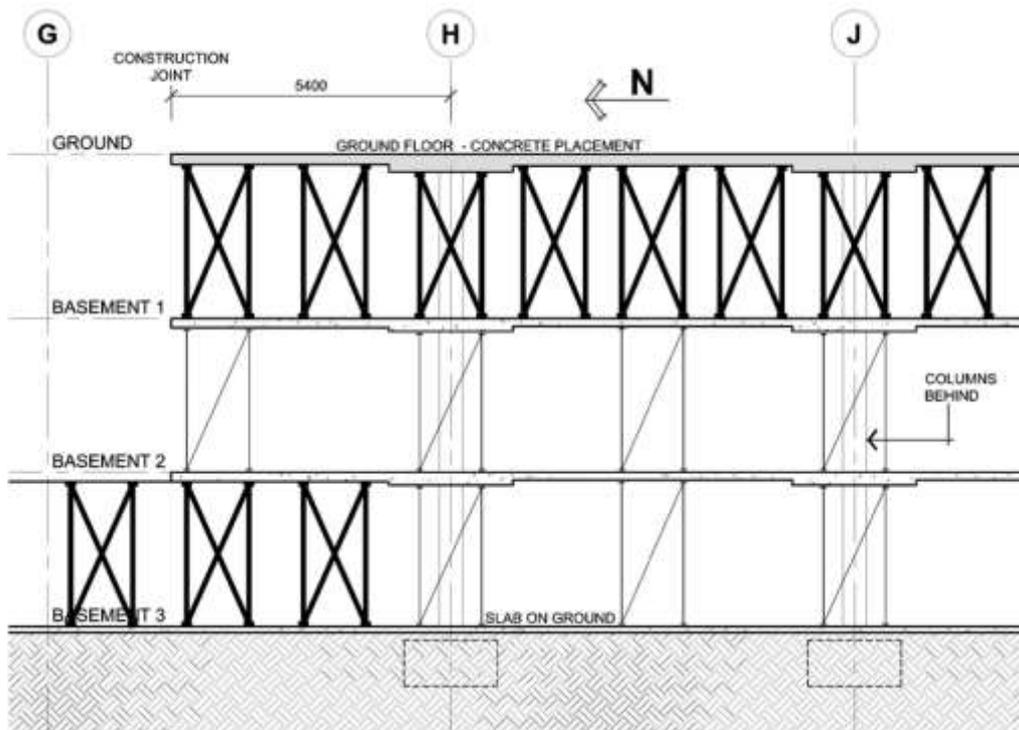
FIGURE 1 TYPICAL SECTION

Figure 1 (below) shows a typical section showing the status of construction at the time of the incident when concrete was being placed to the Ground Floor slab.

Figure 1 shows areas that were fully formed and propped and those which had been stripped and backpropped. In summary the installations were as follows:

- Between Basement 1 and Ground Floor the full formwork system was in place to support the wet concrete placement to the Ground Floor.
- Between Basement 2 and Basement 1 the formwork had been stripped and replaced with a system of backprops.
- Between Basement 3 and Basement 2, south of Grid H, the formwork had been stripped and replaced with the system of backprops.

Between Basement 3 and Basement 2, north of Grid H, the formwork remained in preparation for casting Basement 2 north of the construction joint.

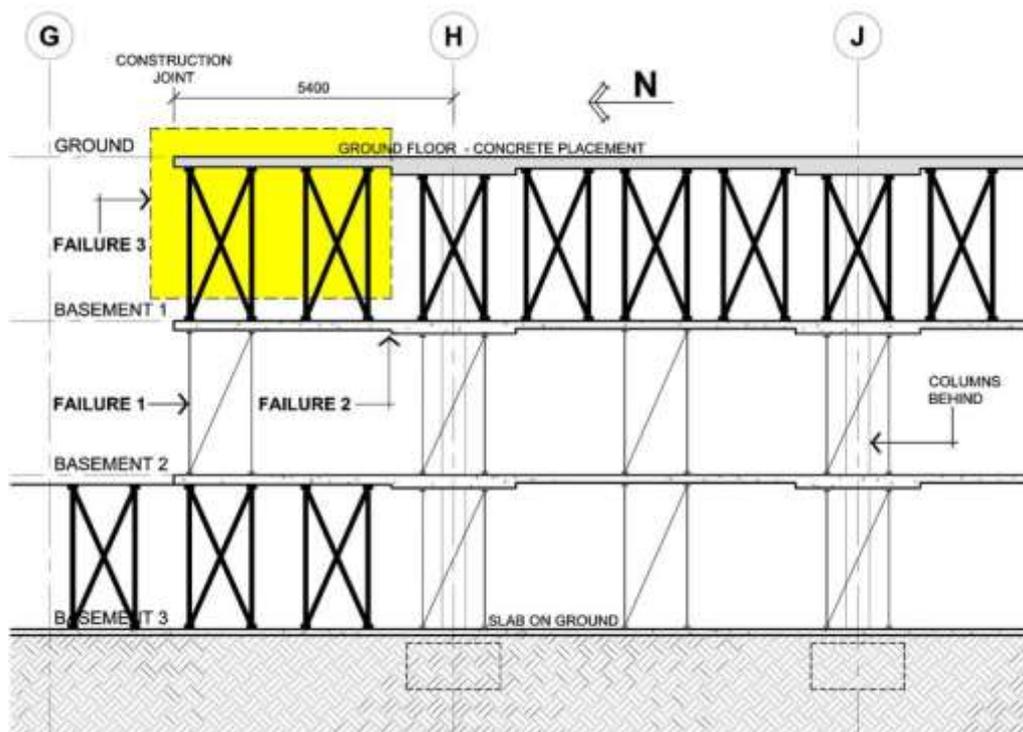
Figure 2 (below) highlights the sequence of the three failures that occurred, leading to the collapse of the formwork and wet concrete to the Ground Floor.

Failure 1 – Backpropping between Basement 2 and Basement 1

As the concrete was being placed to the Ground Floor, north of Grid H, the Basement 2 to Basement 1 backprops became overloaded and began to progressively fail across the entire width (east to west) of the Basement 1 slab, a distance of some 32 metres. The progressive failure of the backprops produced visible deflections in the Basement 1 slab, north of Grid H, alerting site staff and leading to the safe evacuation of all site personnel.

Failure 2 – Overloading of Basement 1 Slab, North of Grid H

Failure 1 resulted in the full load of the Ground Floor wet concrete being carried by the now unsupported Basement 1 slab which in its temporary state, was now required to act as a cantilever. This load was in excess

of the slabs structural capacity resulting in a progressive failure of the Basement 1 slab along the entire edge of the band beam (east to west) adjacent to Grid H. At Failure Point 2 a “hinge” was created at the band beam / slab junction at Grid H. As a result the northern most edge of the Basement 1 slab rotated downwards, coming to rest on the Basement 2 slab below.

Failure 3 – Collapse of Ground Floor Formwork

Without any support from the Basement 1 slab the formwork supporting the wet concrete to the Ground Floor (highlighted yellow in Figure 2) slid down the inclined surface of the collapsed section of Basement 1 slab and came to rest on the Basement 2 slab and formwork. The Basement 2 slab, north of Grid H, remained intact throughout the incident.

Principal Contractors must ensure that formwork and backpropping design drawings are produced that are project and area specific. This is because design loadings for the permanent structure vary from floor to floor, particularly as the project progresses from basement levels, through the Ground Floor and into typical tower floors.

- Principal Contractors must ensure that a review of the formwork and backpropping design is carried out by the Project Structural Engineer to verify that temporary imposed loads will not adversely affect the permanent structure.

- The Principal Contractor should provide marked-up drawings to the formworker which identify the areas that can be stripped and backpropped prior to the formworker commencing those activities.

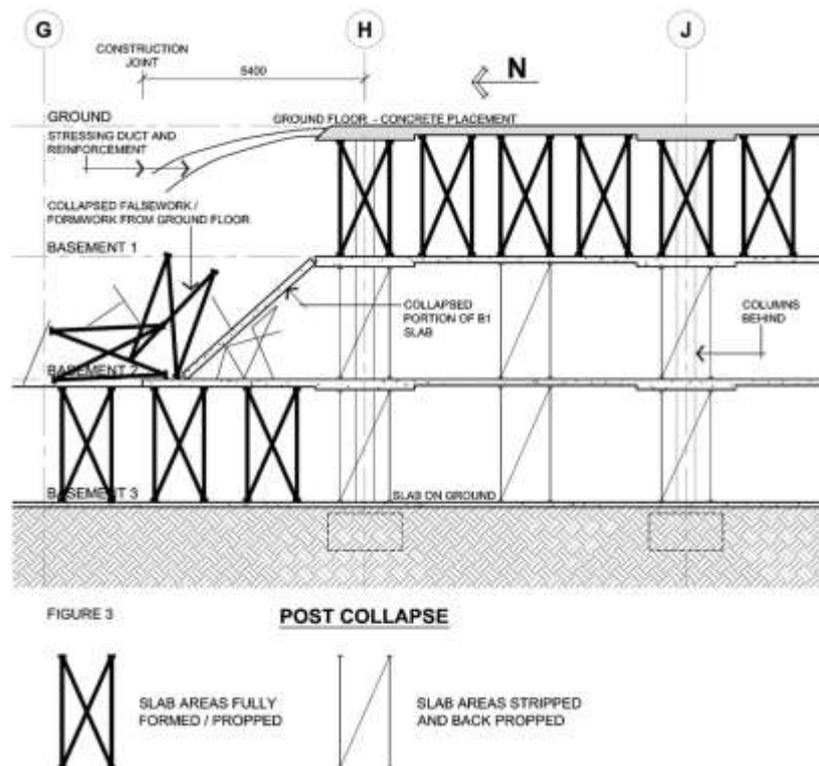
The result of the three failure mechanisms outlined above is demonstrated in figure 3 (below).
